# QUINHAGAK, ALASKA

## Kanektok River Erosion Study

February 2019

CRW Engineering Group, LLC  
3940 Arctic Blvd. Suite 300 Anchorage, AK 99503

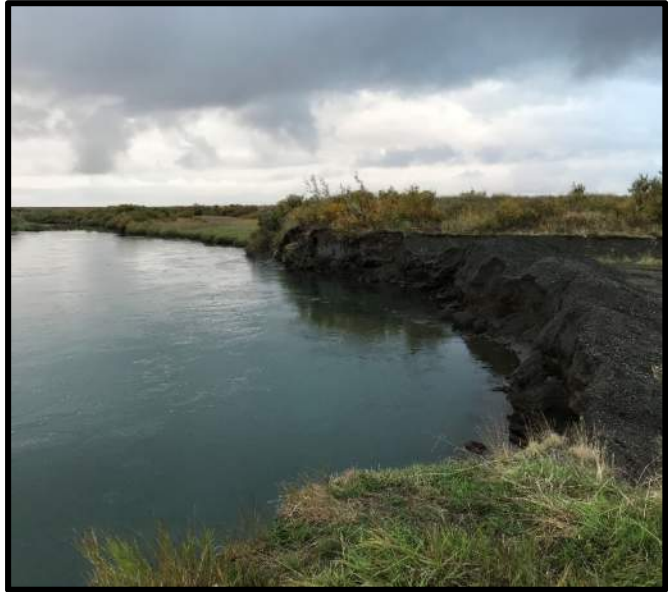
**Photo 2 – Erosion at End of Former Runway**

The eastern end of the former runway is identified as having the most pressing erosion concern for the community. While this area may have seemed like a good location for gravel extraction, those actions have made this area vulnerable to increased erosion and any removed fill should be replaced to help minimize future erosion. According to the Herrera analysis, the river could occupy the runway at this location which could cut-off the nearby access road to needed gravel sources and allow the river to run closer to existing buildings including the school. As recommended in the Herrera report, this area should be refilled to the level previously excavated to provide some level of mitigation. This area will continue to erode until a long-term erosion mitigation measure is installed.

As discussed in the Herrera report, the combination of lack of vegetation along the runway, loosely layered sediments (alluvium substrate) and the high velocities in the river, mean that erosion along this area is expected. Similar to concerns at the east end of the runway, this area has the potential to allow the river to access low ground and create a new channel closer to the community. It does not appear that this would be an imminent risk to the community but does present a long-term risk that should be addressed.

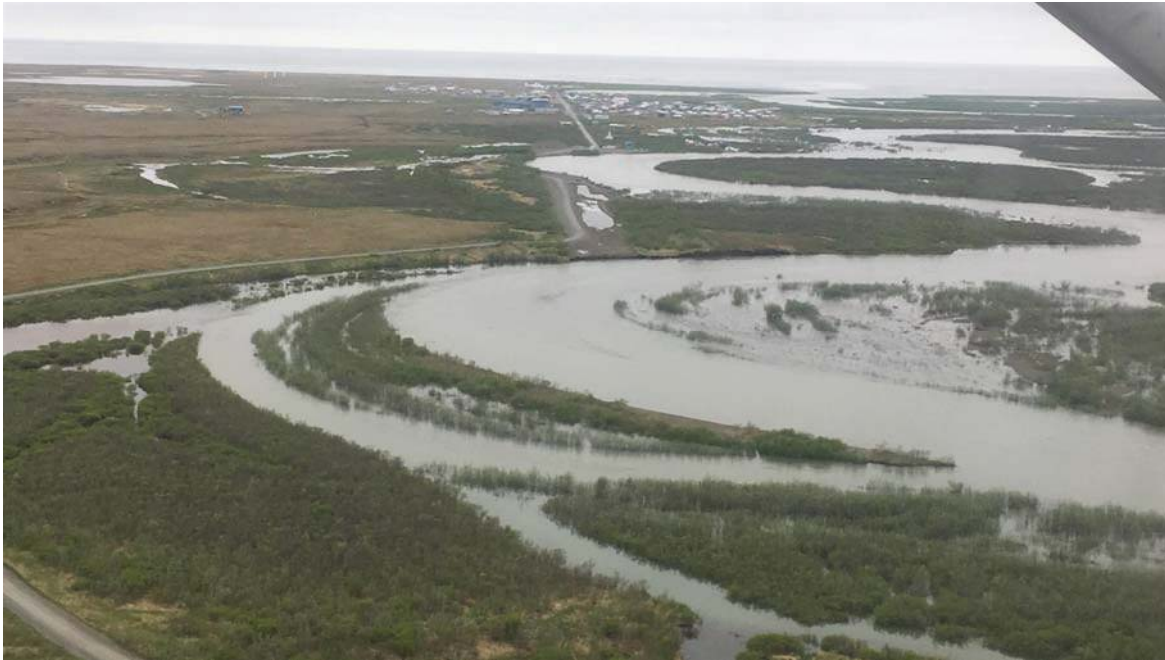
*Old Runway Eroding and High water on the Kanektok River*

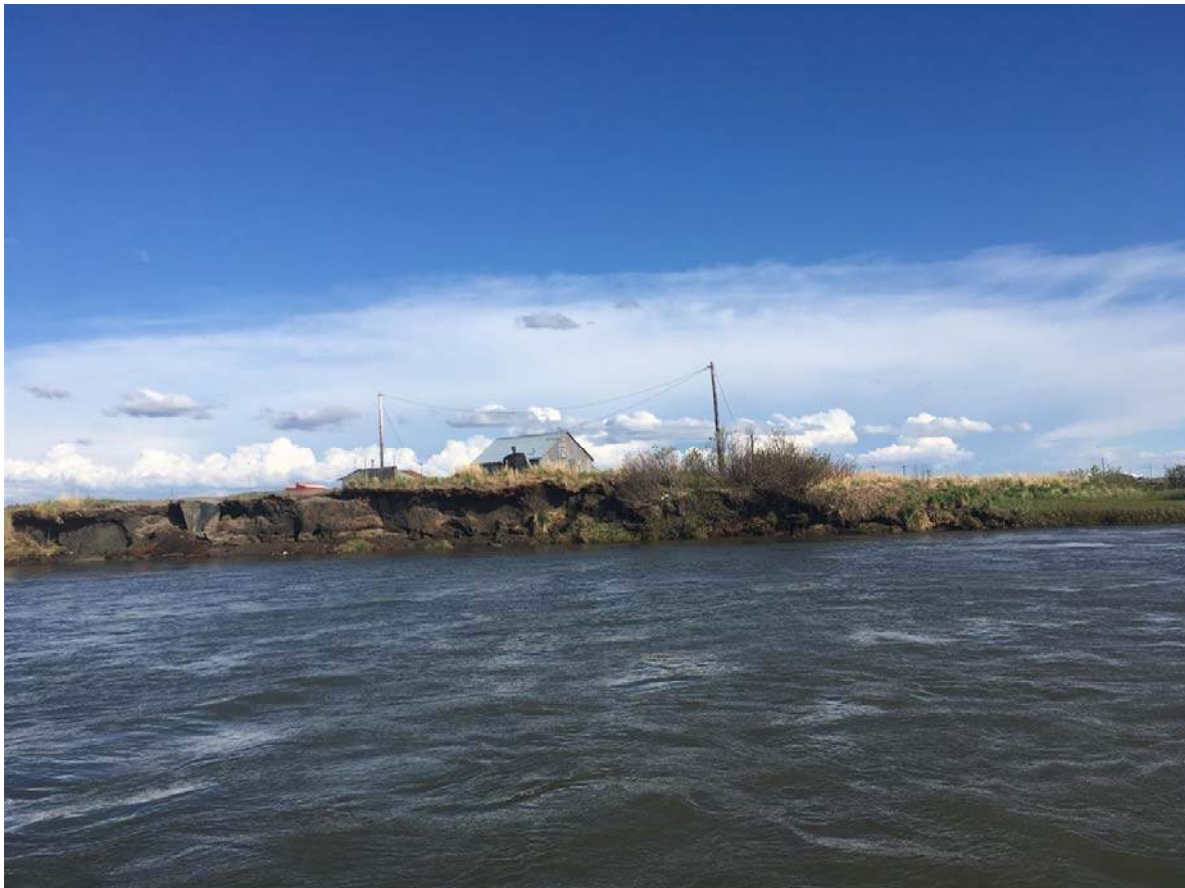
*Erosion at the north end of Service Area 7*

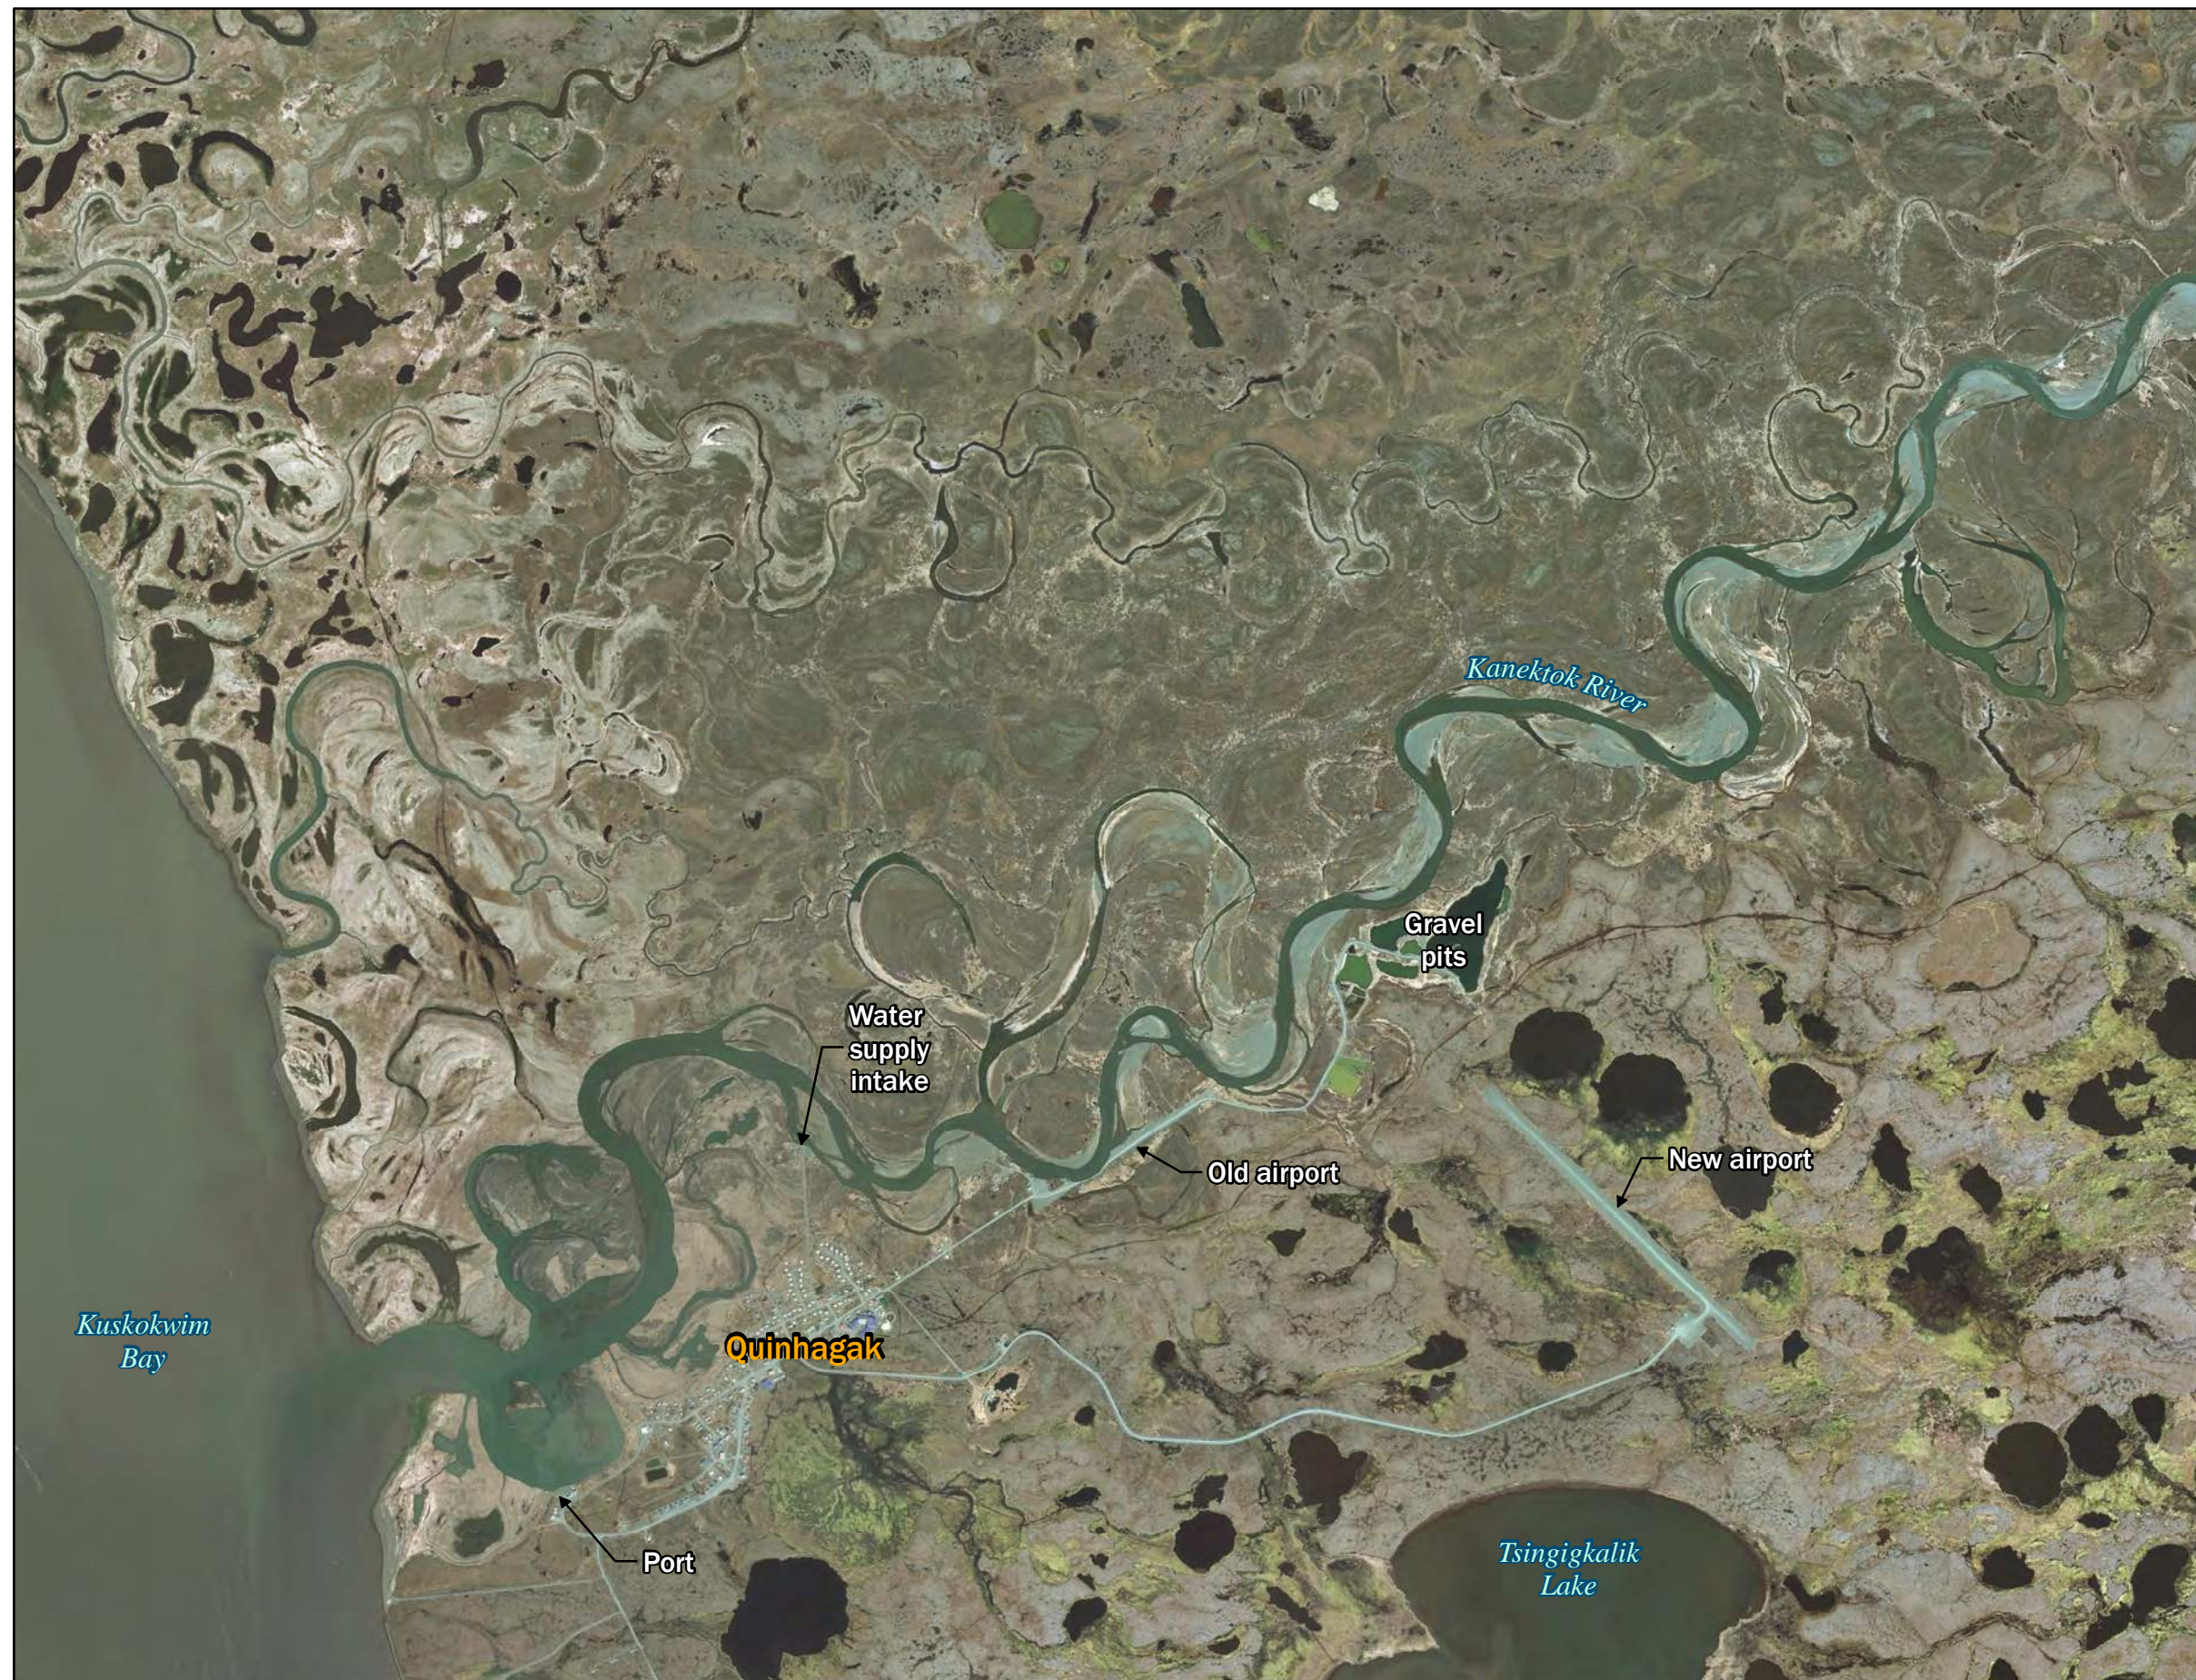
Figure 1.  
Vicinity Map for the Quinhagak  
Erosion Mitigation Planning Study,  
Quinhagak, Alaska.

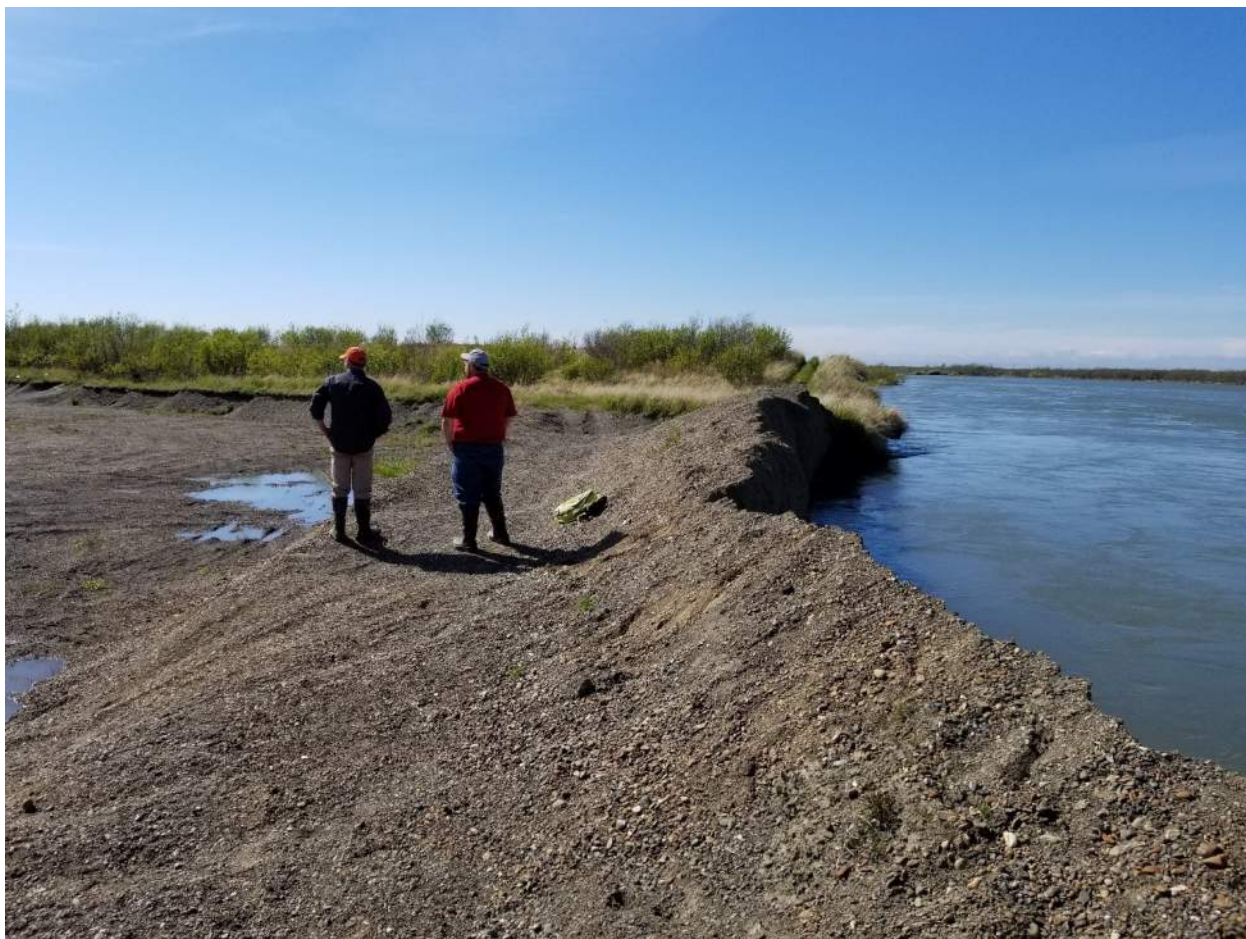
The end of the former runway is the most pressing erosion concern. As can be seen in Figure 2, excavation has occurred next to a rapidly eroding bank. Removed fill should be replaced immediately to prevent occupation of the river south of the former runway. Occupation of these areas will not only compromise the road and access, but it could enable the river to flow close to existing buildings, like the new school. Fill materials do not necessarily need to be composed of sand gravel but should be placed at least to the elevation of eroding bank in Figure 2. Even with replacement of fill, the bank will erode; and protection is recommended (though not urgent once the bank material is replaced).

**Figure 2. Looking Downstream at the End of the Former Runway, Quinhagak, Alaska.**

The former airport was the principal concern of the community. It is the location where past erosion has placed access to gravel at the greatest risk. Erosion in this location started to become a problem when a former gravel pit was captured by the river near the former runway sometime in the 1990s. This has been a site of past super sack deployments. According to most interviewees and onsite observations, these treatments were only temporarily effective.

Because of the lack of vegetation, loose alluvium substrate and the high velocities in this area, future erosion in this location is expected. It is likely that the access road will be lost in a relatively short period of time (a few years or less). Like at the end of the former runway, the biggest concern is that the river will access low ground south of the old runway and develop a new channel closer to the community. Although this is not an imminent risk to the community (aside from the loss of access to gravel sources), it does present a significant long-term risk to the community and should be addressed.

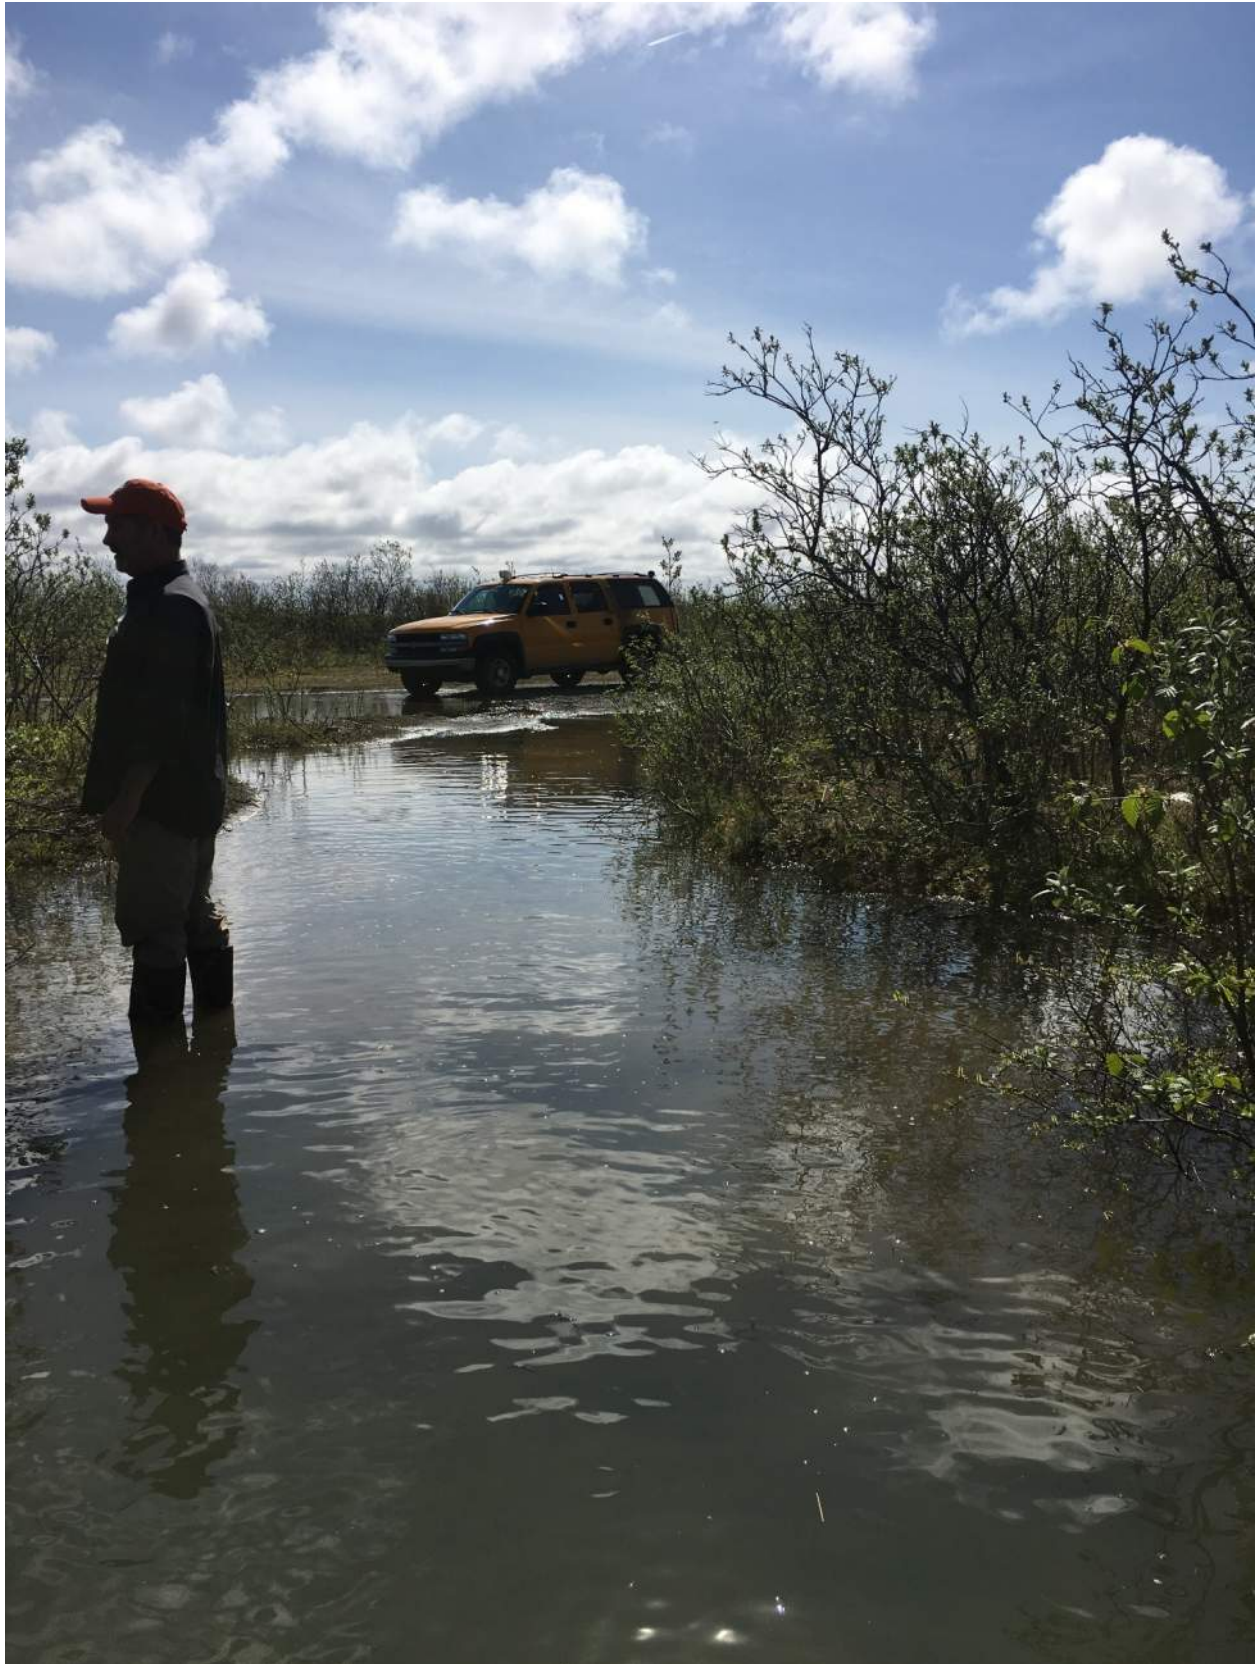
**Figure 3. Flow Over the Water Supply Road on June 5, 2018, in Quinhagak, Alaska.**

On June 5, flow over the water supply road was observed (Figure 3). Overtopping is also seen in the model beginning in the 2-year event. Since this is a relatively frequent occurrence, there is a concern of an avulsion in this location. Modeling indicates flow velocities are modest, generally less than 4 feet per second, which is consistent with onsite observations. Currently water flow is constrained by patchy, dense vegetation. Since the path length over which overbank water flow is comparable to the main channel length in this area, it means the probability of avulsion is modest, though overtopping may continue to occur and compromise access to the water supply intake over time.

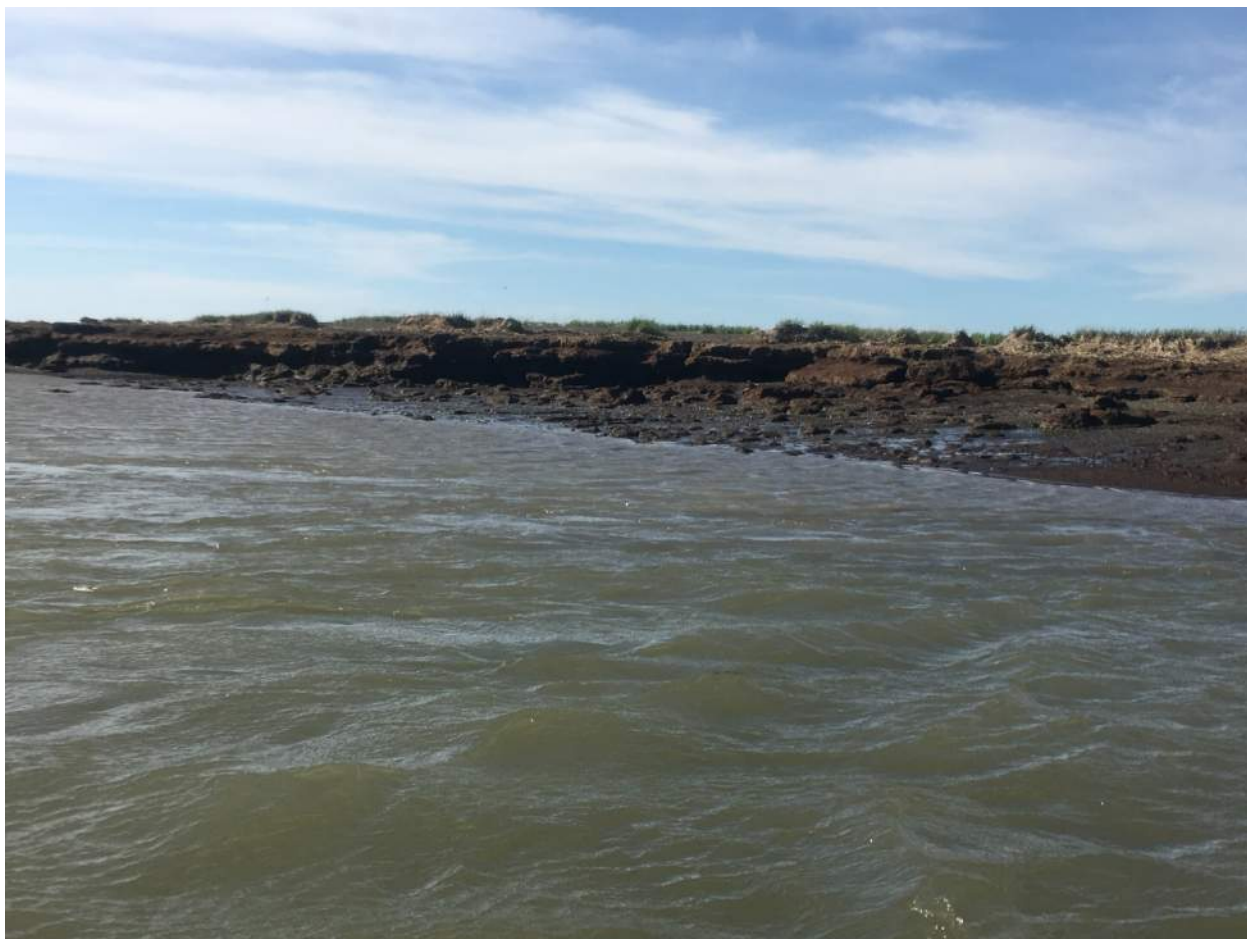
**Figure 4. Eroding Banks on the Right Bank at the Mouth of the Kanektok River.**

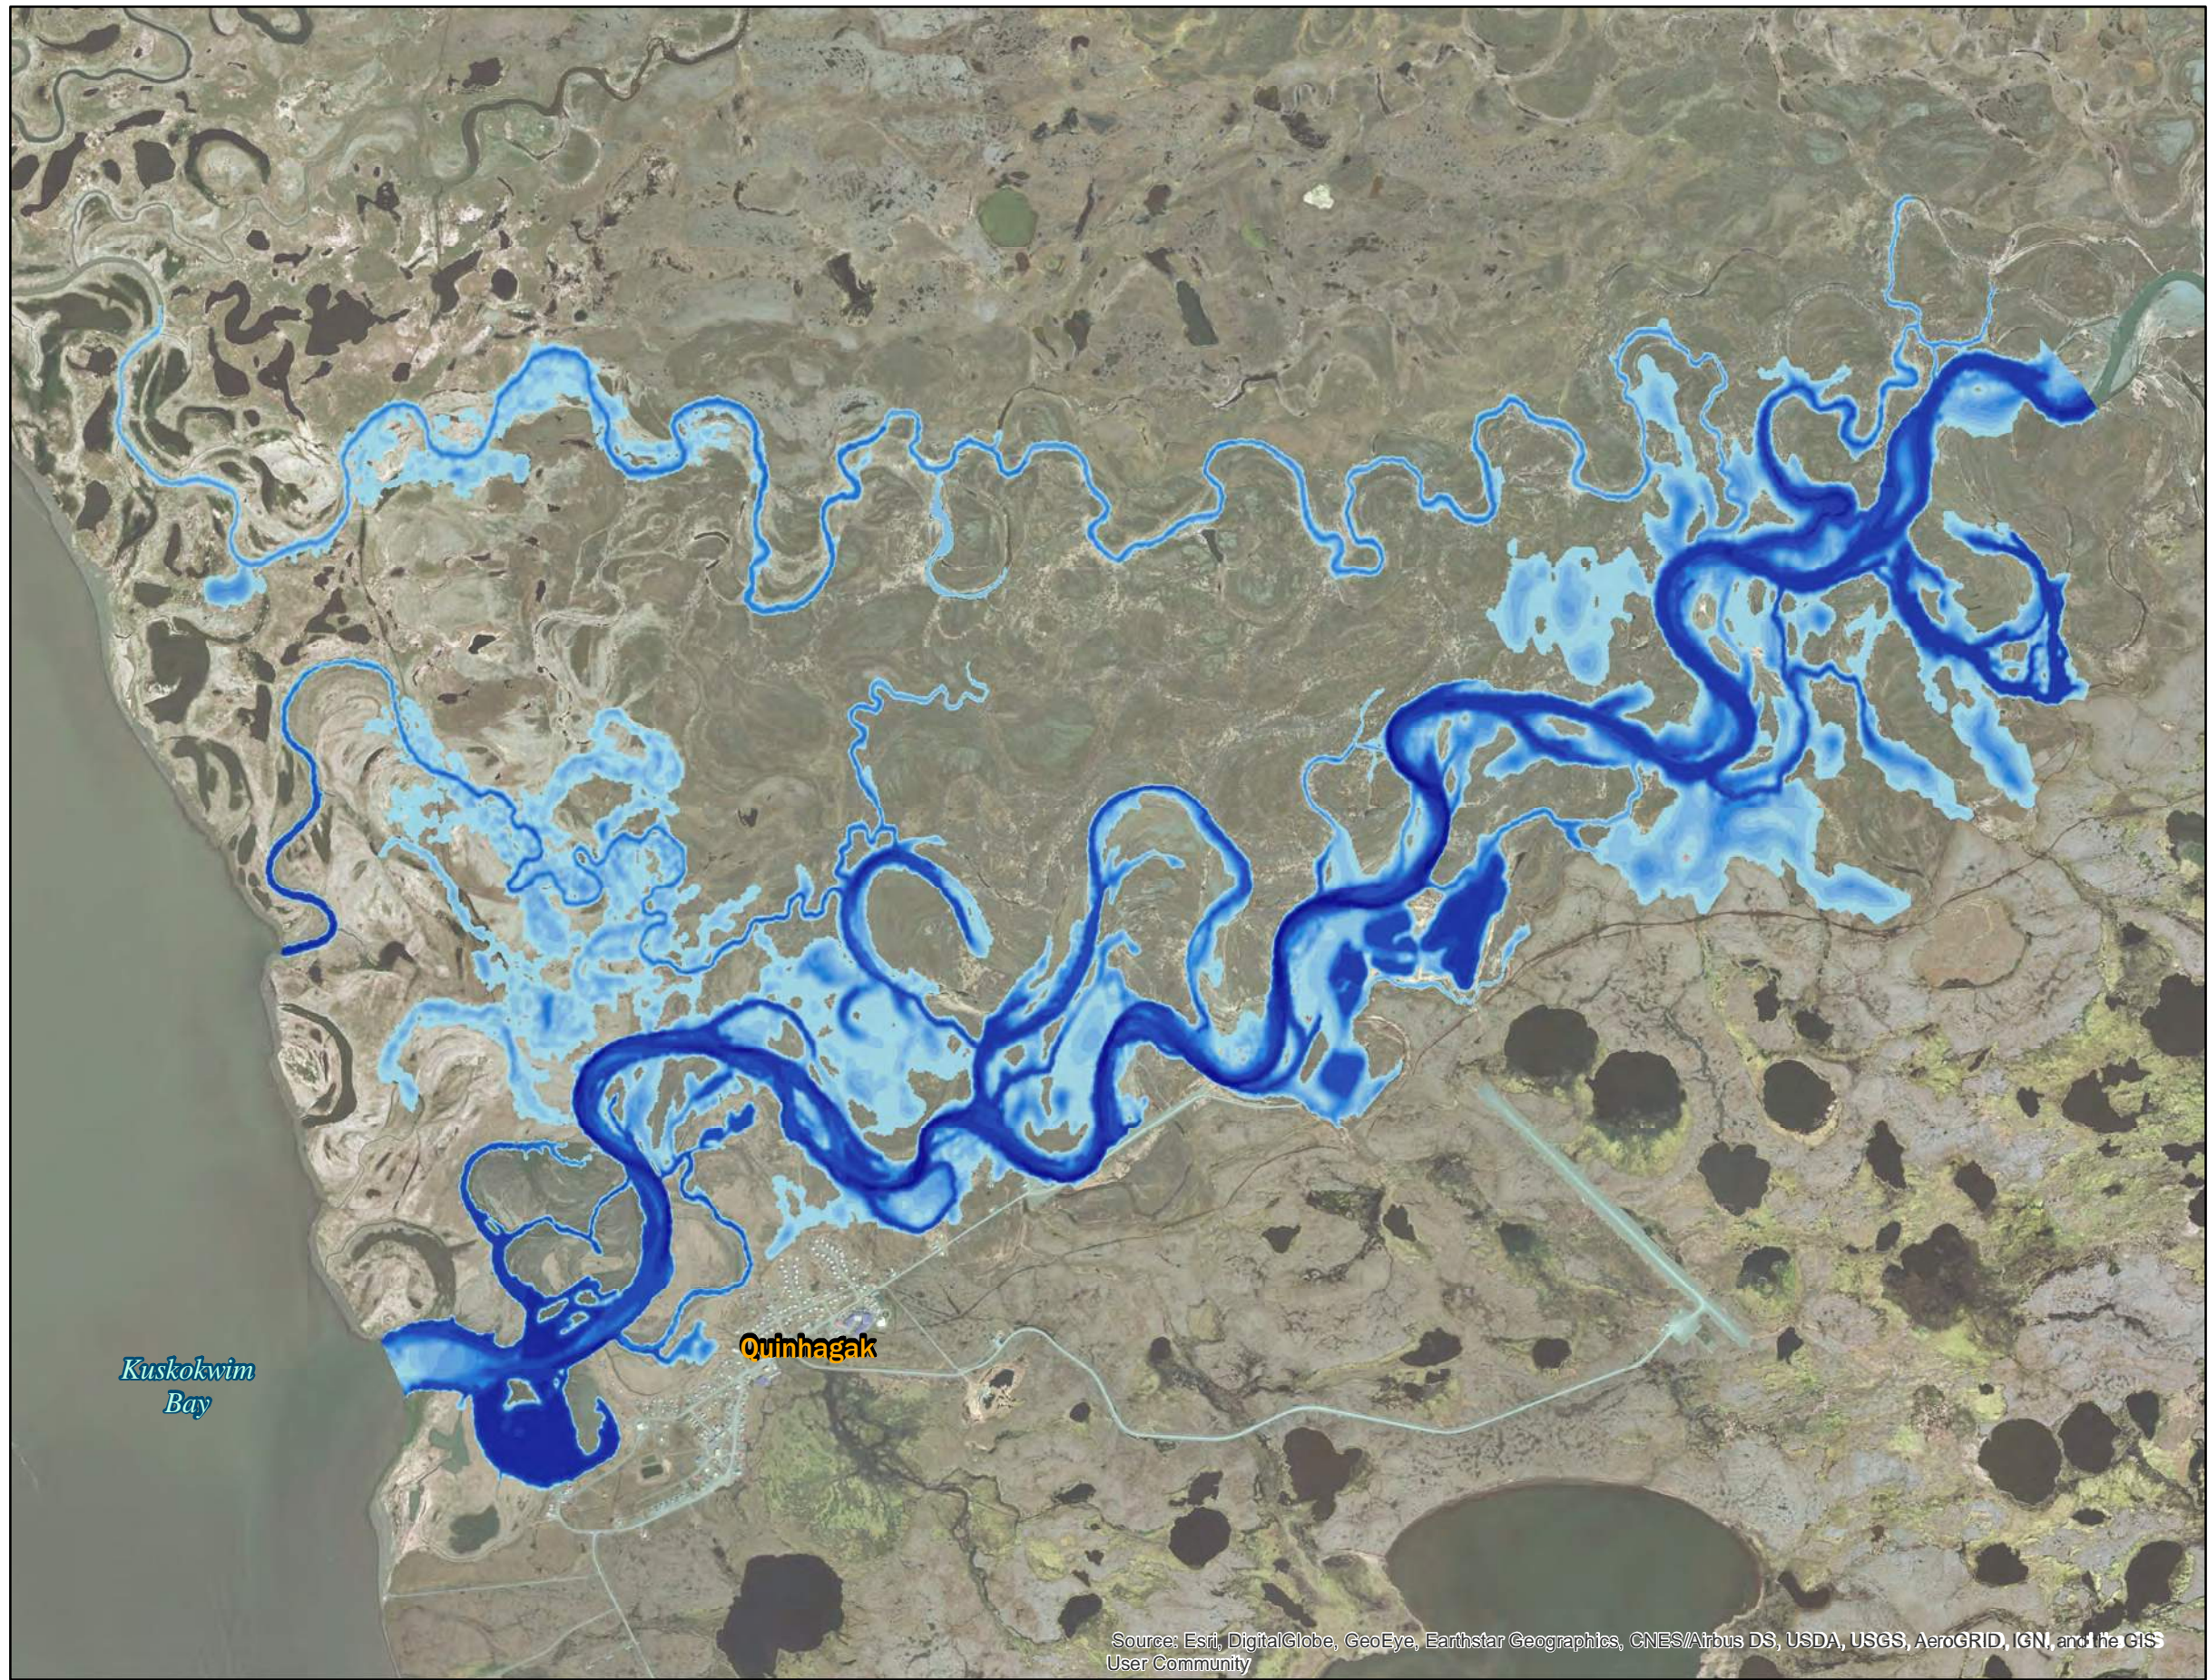
Figure 5.  
Water Depth in the 2-Year Event,  
Kanektok River, Alaska.

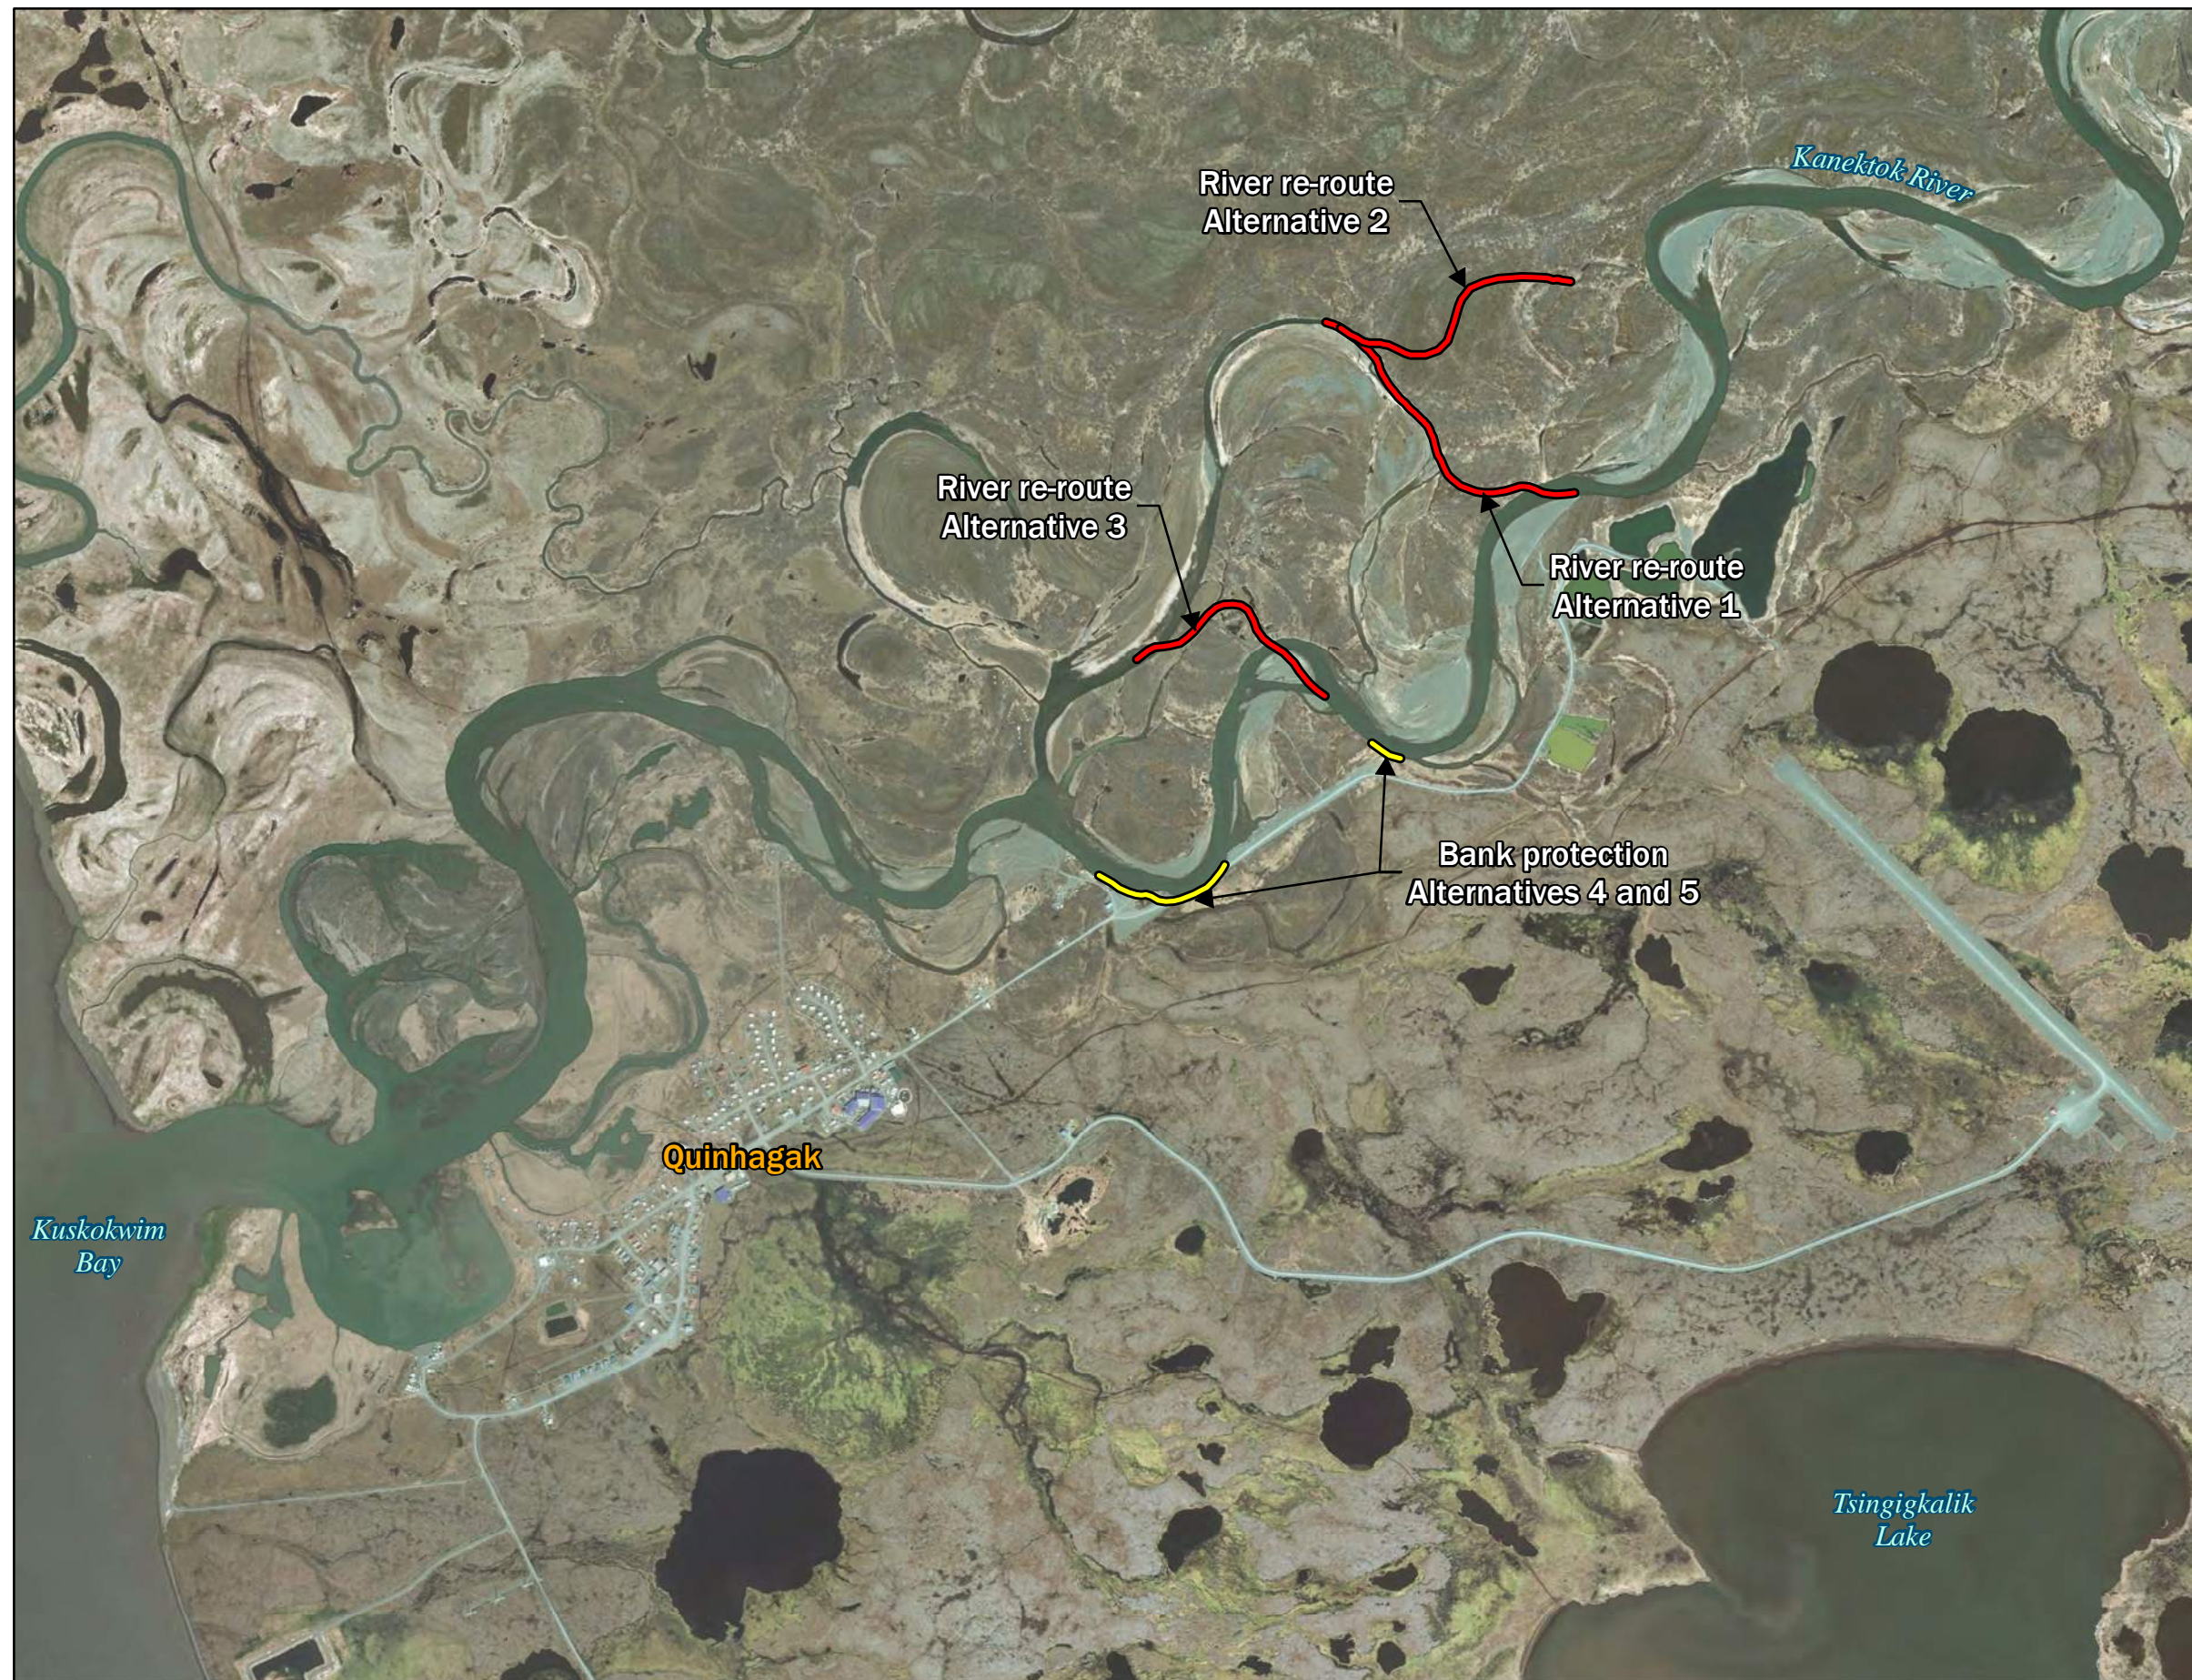
Figure 8.  
Channel Reroute Alternatives and  
Bank Protection Alternatives.

The objective of the alternatives development process was to select combinations of options that would reduce hydraulic and geomorphic risk to the community. The alternatives developed and analyzed as part of the project can be broken into two categories, those that attempt to relocate the river away from critical infrastructure (Channel Reroute Alternatives) and those that protect infrastructure by attempting to lock the river alignment in place using bank protection (Bank Protection Alternatives), which can be seen in Figure 8.

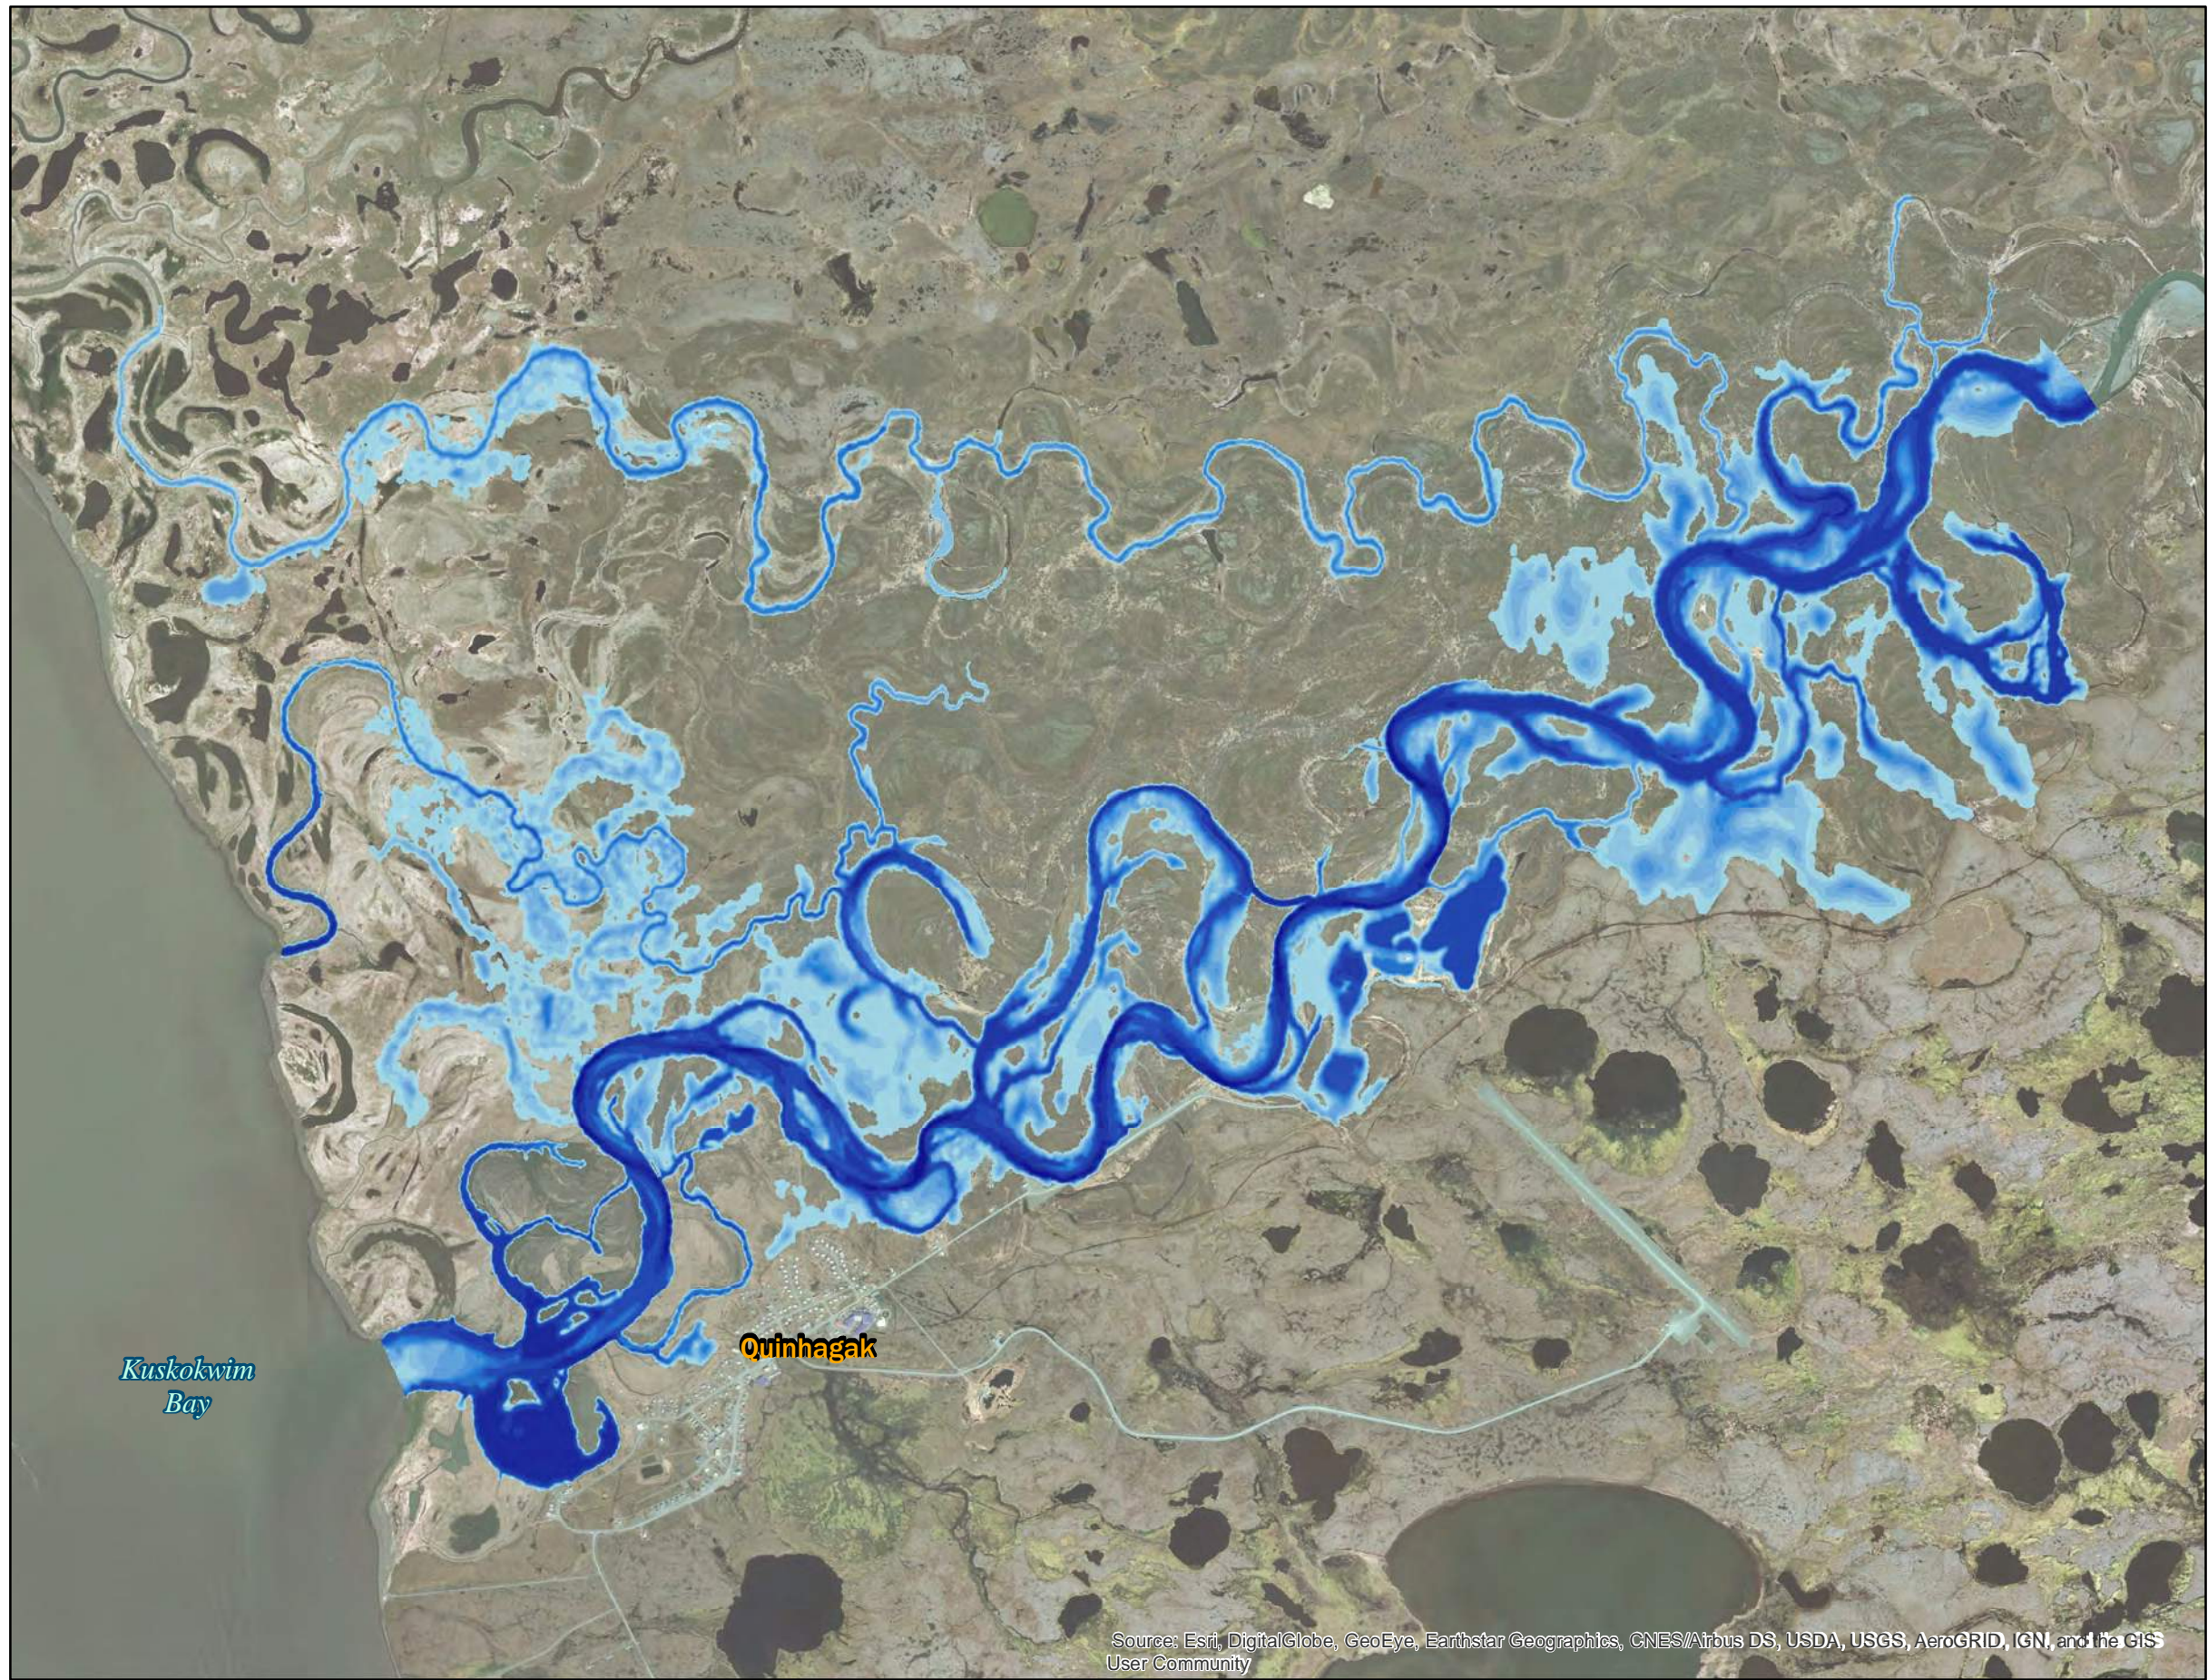
Figure B-1.  
Alternative 1  
2 Year Maximum Depth.
